Operation Rehabilitation Drive: Rapid Flood Impact Assessment in Kuttanad Region

Centre for Policy Studies, Centre for Technology Alternatives for
Rural Areas and Civil Engineering Department, IIT Bombay

Kerala Institute of Local Administration (KILA), Kerala

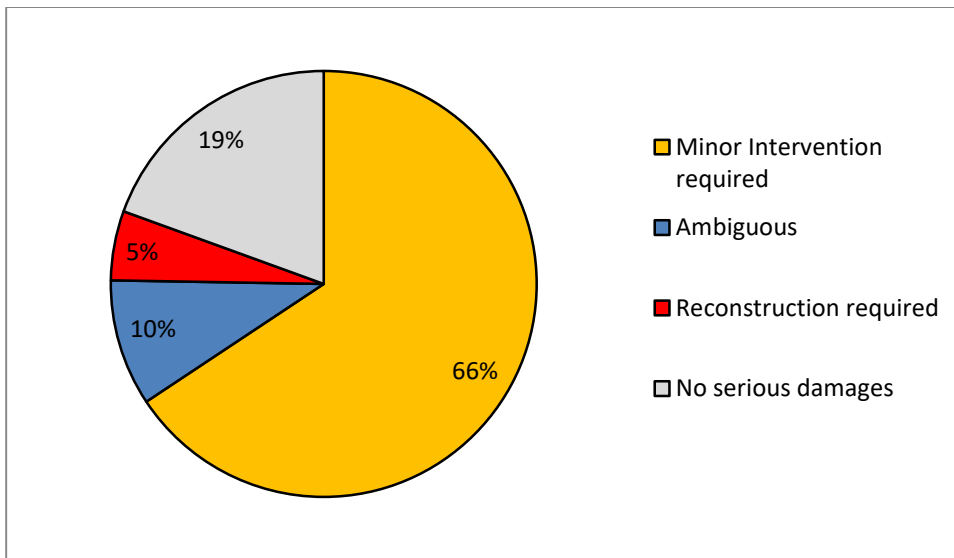
Figure 8: Distribution of Structural Damages

As of now, 740 of these houses have been analysed by experts based on a format prepared by them (See Appendix -2). **Based on photographs, the experts identified 5.27% of the buildings as requiring complete reconstruction.** Similarly 65.67% of the samples require some intervention and 19.45% did not require any major renovation. Given that the judgement was based solely on photographs, the experts were unable to effectively assess the remaining 9.59% of the samples.

When the conclusions of experts were compared with those of the survey volunteers it gave interesting results. Of the 740 houses analysed, the experts classified 39 as critical, requiring reconstruction. Of these, the volunteers failed to identify 10. In essence, they managed to identify nearly 75% of the houses that required reconstruction. Similarly, the disagreement between experts and volunteers in case of houses that require some intervention was only over 13% while it was less than 5% in case of houses that were relatively undamaged.

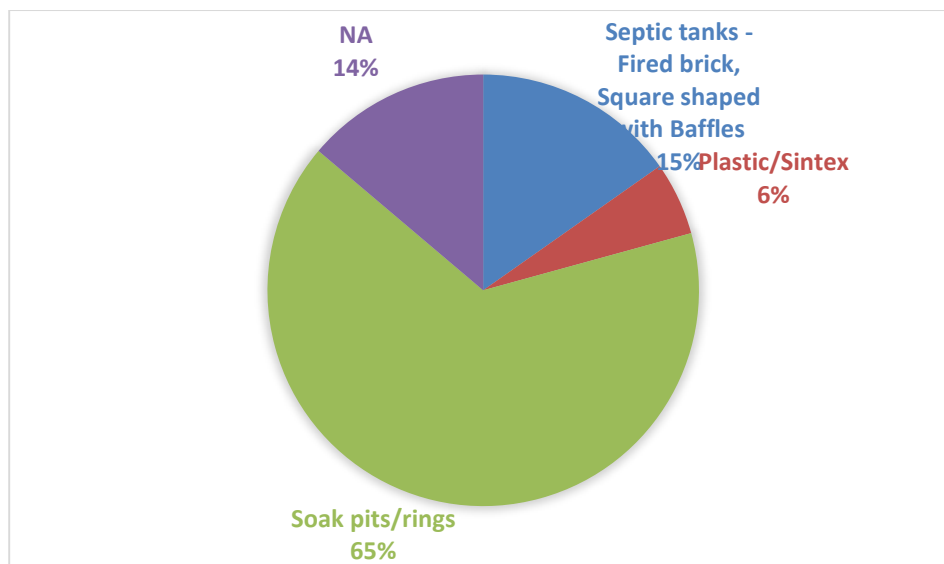
Figure 13 Septic Tank Construction

As such, no major issues were observed in personal hygiene as 95% of the population claimed to wash their hands before eating and after toilet use. However, solid waste treatment is an entirely different story. While 87% claimed to have septic tanks, over 65% have not been cleaned for the last 5 years. Given the average household strength of 4 people, this frequency is worrisome. Additionally, 56% of the households with septic tanks claimed that the tank was not cemented or that they were unaware of the type of construction. The type of material used also provides key insights. Over 65% use concrete rings. Such tanks are unlikely to be airtight, especially if the bottom is not concreted. Proper syntax tanks of tanks constructed specifically for this purpose were used only by 21% of the population. Therefore, it is safe to assume that given the level of flooding, all ground water sources are contaminated with solid waste sewage post floods.

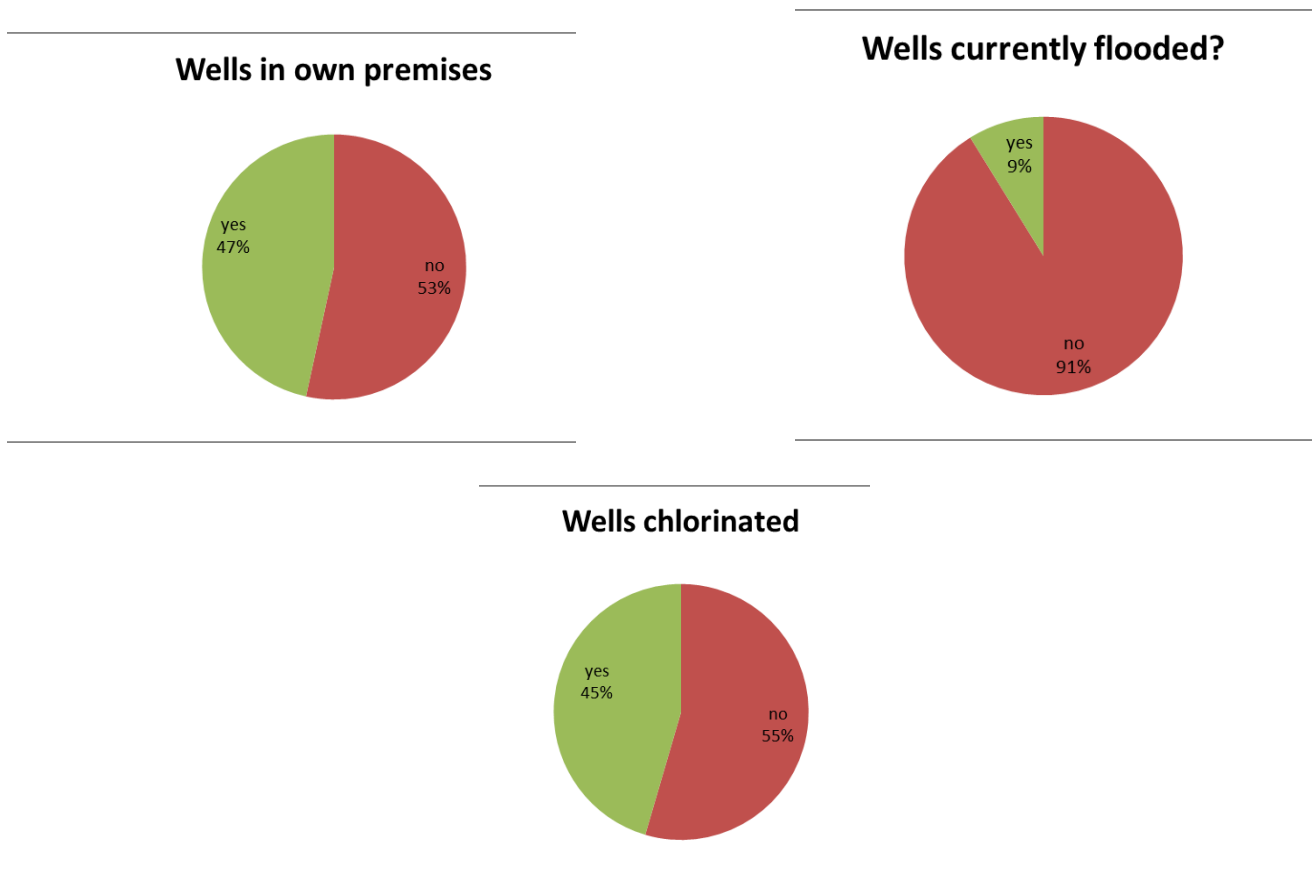
Figure 18: Wells in premises, whether flooded or chlorinated?

Less than half of the institutions had well within their premises. Out of these only about 9% of the wells were flooded currently. The chlorination has happened only in around 45% of the wells. All wells are advised to be chlorinated before they are to be used again especially for drinking or cleaning of vessels.

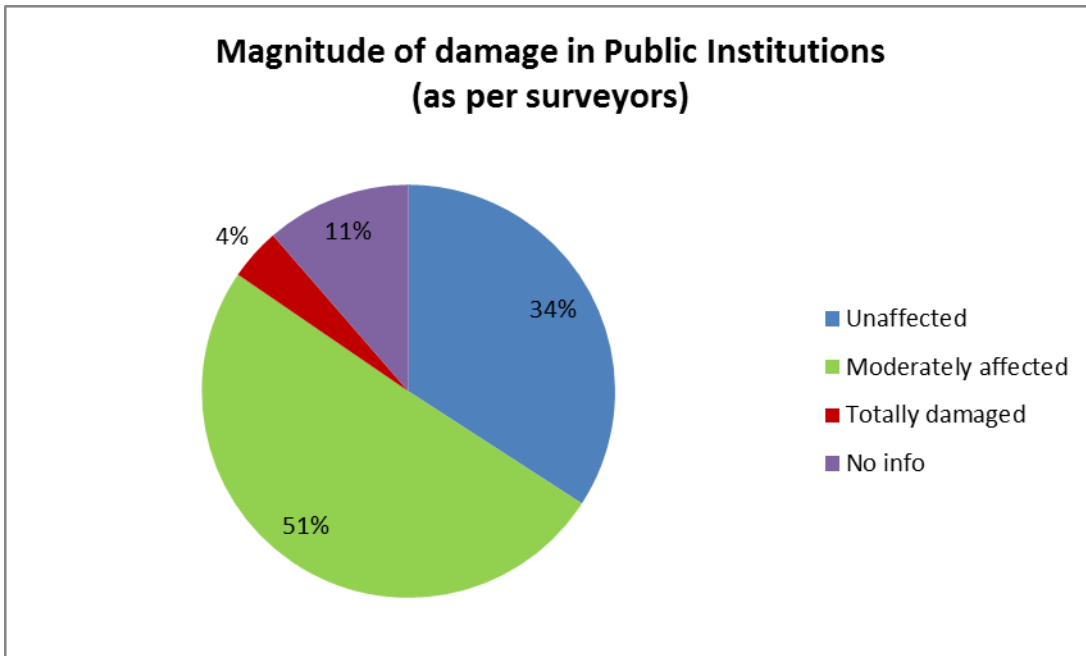
Figure 19: Magnitude of damage in public institutions

As per the surveyors, 4% of the institutional buildings were found totally damaged, while 51% were found to be moderately. Thus more than half of the institutional buildings surveyed were observed to be damaged by the surveyors. About 34% of the houses were observed to be unaffected, while no info could be gathered from the rest of the institutions as they were closed. Photos of these public institutions were shared with the experts of civil/structural engineering at IIT Bombay. 89 of these institutions in 8 panchayats were analyzed for structural damages due to floods.

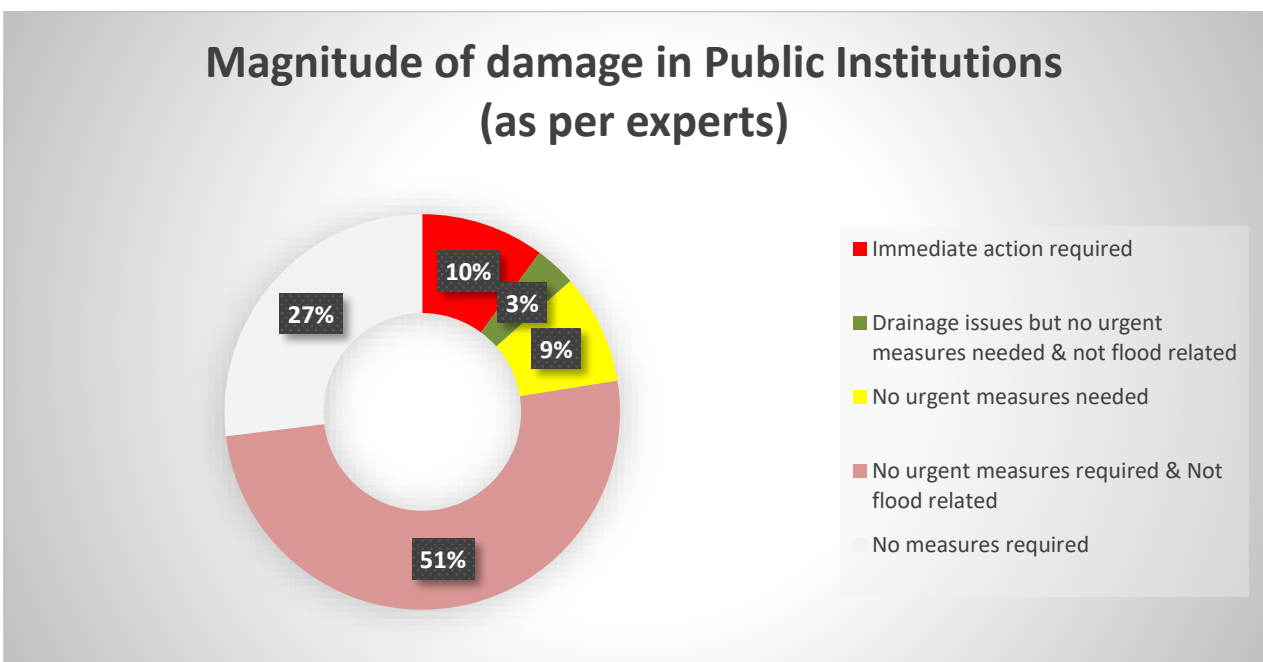
Figure 20: Magnitude of damage in public institutions by experts

Out of the 9 institutions which needed immediate action as found by the experts, the survey team had identified 8 of them as having moderate effect or totally damaged. In rest of the institutions, the experts could distinguish between the damages caused by the floods and the ones that were older. Based on this, the experts could categorize the magnitude into 5 different categories as in the figure above. In future such exercises, there is a need to train the surveyors how to identify the damages caused by floods as against the older ones. Although only 10% of the public institutions require immediate action, the floods could have worsened the already existing structural damages and cracks in rest 63% of buildings found to be having problems based on photos and surveys. Magnitude of Damage of Public Institutions was also plotted in QGIS for further analysis and to find if there are any clusters.

- About 10% of the public institution buildings surveyed need immediate action.
- There has been a considerable loss of infrastructure in the schools, anganwadis, primary health centres and government offices due to the floods. Along with the reconstruction work on the buildings, focus should also be to repair and buy new infrastructure for these public institutions.
