TATA CENTER FOR TECHNOLOGY AND DESIGN-IIT BOMBAY

Phase one report submitted

SUSTAINABLE HOUSING SOLUTIONS FOR

FLOOD-PRONE AREAS:

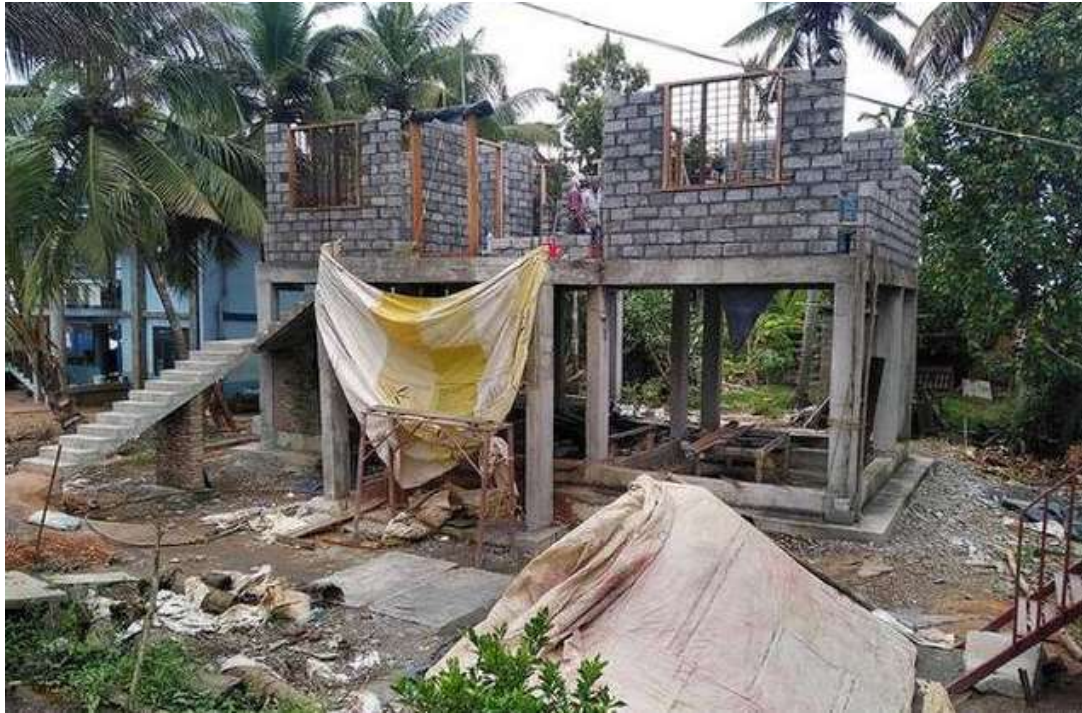
Figure 8 : Typical Under-Construction House on Pillars in Kainakary, Kuttanad (Paul, 2019)

- [Data from (Anderson, 2014)]: One of the most common retrofitting methods is elevating a house to a required or desired Base Flood Elevation (BFE)¹. When a house is properly elevated, the living area will be above all but the most severe floods. Houses on Piles are a type of housing built on top of concrete, steel or wooden poles and can be found in shallow water, coastal areas, or lakes where fluctuations in the water level can be predicted. **This type of dwelling typically rests 8-15 feet (2.4 to 4.6 m) off the ground** and has been used throughout the world as means of protection from water.

- **Timber pilings:** Timber pilings have been used for 6,000 years and continue to be one of the leading types of driven piles. Timber is often used in pile foundations because it is a readily available and renewable resource. Because it is light in weight, timber is also more easily handled, driven and cut than other types of piles. According to (van Alphen, 2020), timber pile foundation underwater will last indefinitely and timber piles partially above water can last up to 100 years or longer if they are properly prepared and treated. Evidence suggests that Coconut Wood was used to raise chalas in Kuttanad during flood season².

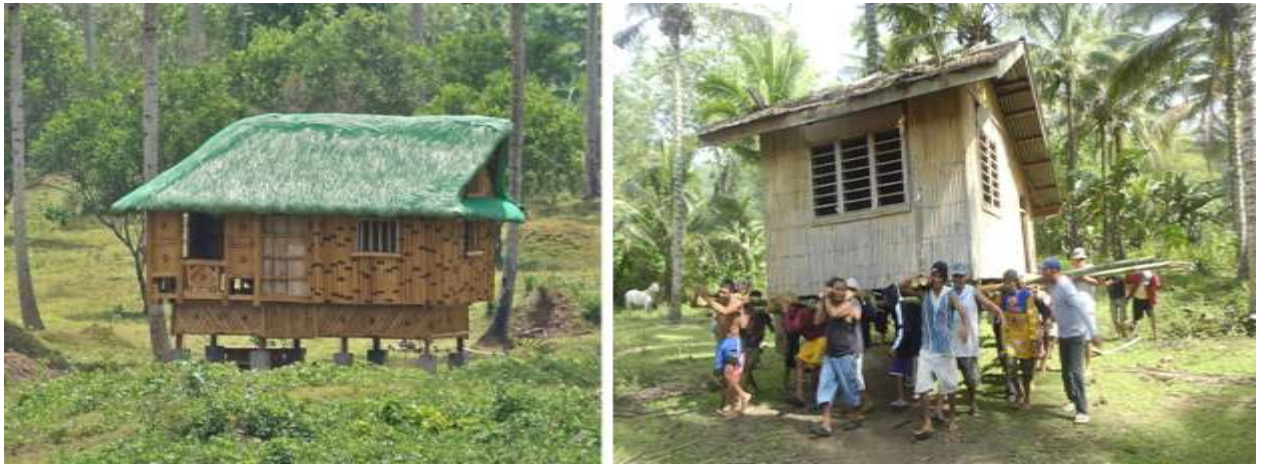
Figure 9 : Modern Nipa hut (left). Hut being moved to a different location by community members (right). Open Source

- **Case-Example- "Nipa Huts":** The "Nipa hut" is the primary type of housing found in the Philippines. The walls of the living area are made of light materials. Posts, walls, and floors are typically made of wood or bamboo and other light materials. The thatched roof is often made of nipa or anahaw³ (palm tree leaves). Thus, making it easier for the nipa huts to be moved if needed.

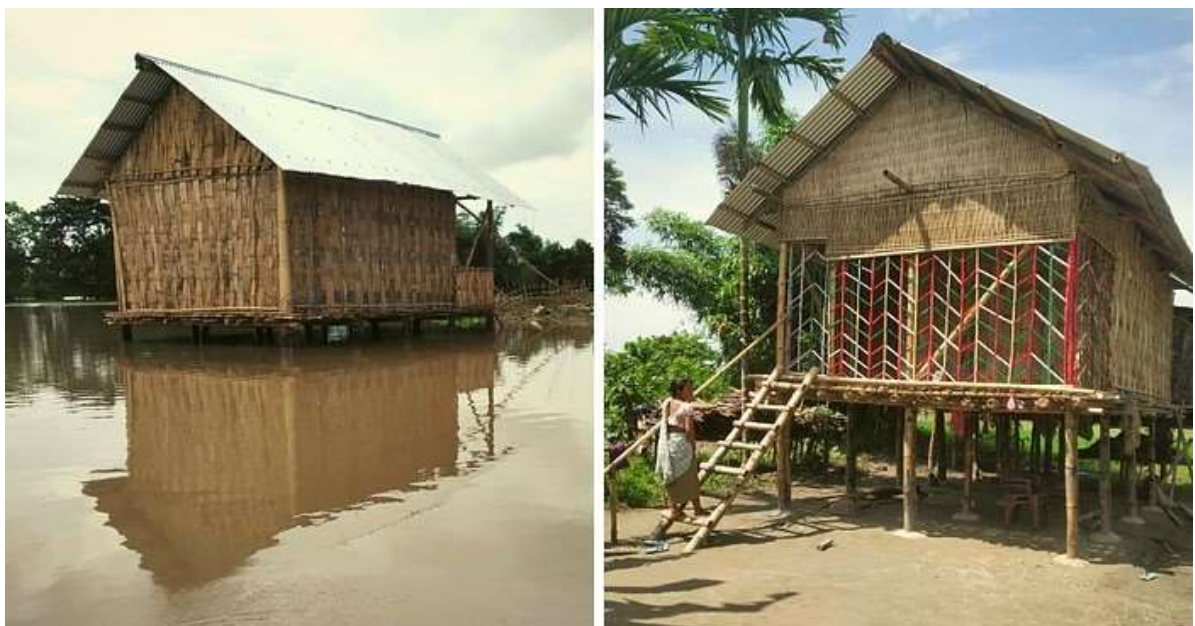
Figure 10 : Bamboo Stilt houses in Golaghat, Assam by SEEDS NGO

○ **SEEDS⁴ Bamboo House in Assam:**

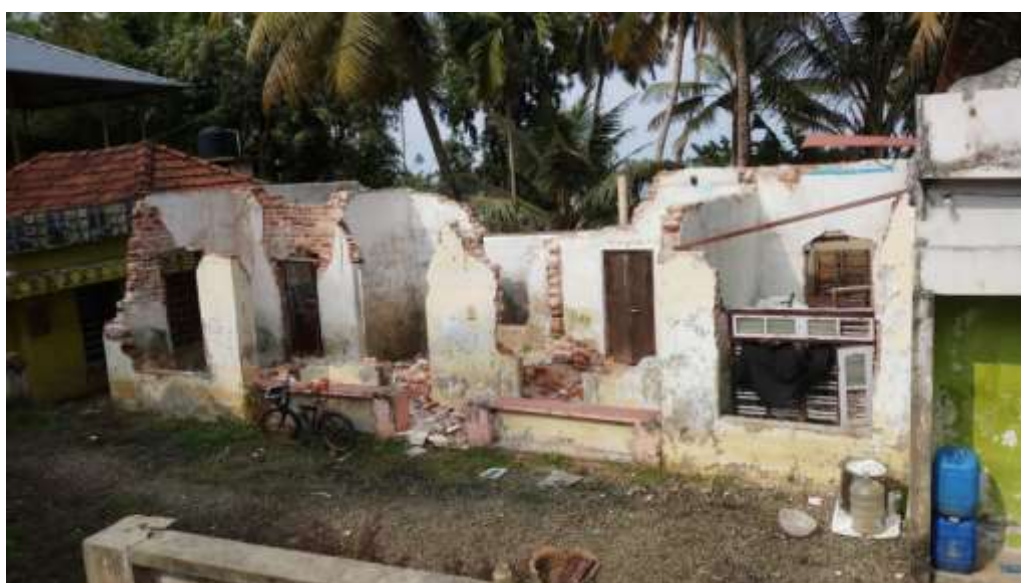
Figure 39: House completely damaged by floods, Primary Survey 2019

The flood waters remained stagnant in large parts of the Kuttanad region for periods of over a month, while in certain areas owing to the topography, the water receded quicker and households were able to return to their homes. The overall process of surveying and estimating the damages brought on by the floods was started after the water receded entirely from the region approximately 2 months after the flood. The main survey to assess housing damage was done via village authorities where a team lead by a civil engineer examined the structural damages to the houses. According to data released by the Govt. of Kerala, a total of 57597 houses were damaged by floods in Alappuzha district of which an estimated 56070 houses were partially affected by floods (Rebuild Kerala Data, 2019), while 1527 were completely affected by floods. In Kainakary gram panchayat, a total of 2886 houses were affected by floods of which 2699 were partially affected by floods, while 187 houses were completely affected and in Nedumudi gram panchayat, a total of 2891 houses were affected by floods of which 2859 were partially affected and 32 were completely affected by floods.

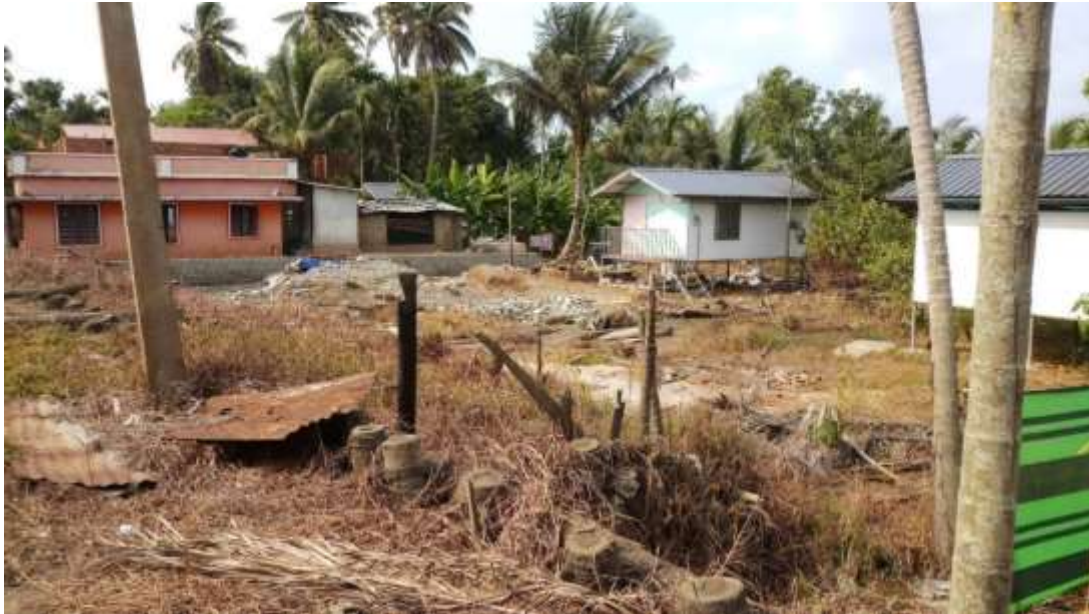
Figure 44: Levelled homes in foreground with Temporary Shelters provided by World Vision in the background.
Kainakary 2019

Note: Due to the severe flooding in Kainakary, there was more complete destruction of houses. The houses which are less than 1 year old are ‘Temporary Shelters’ which have been provided by NGOs, and the families living in these shelters are yet to commence work on their permanent houses. It should also be noted that the location of these houses was adjacent to a bund which collapsed in 2018, leading to severe flooding of the area and most houses got swept, while others were very badly damaged.

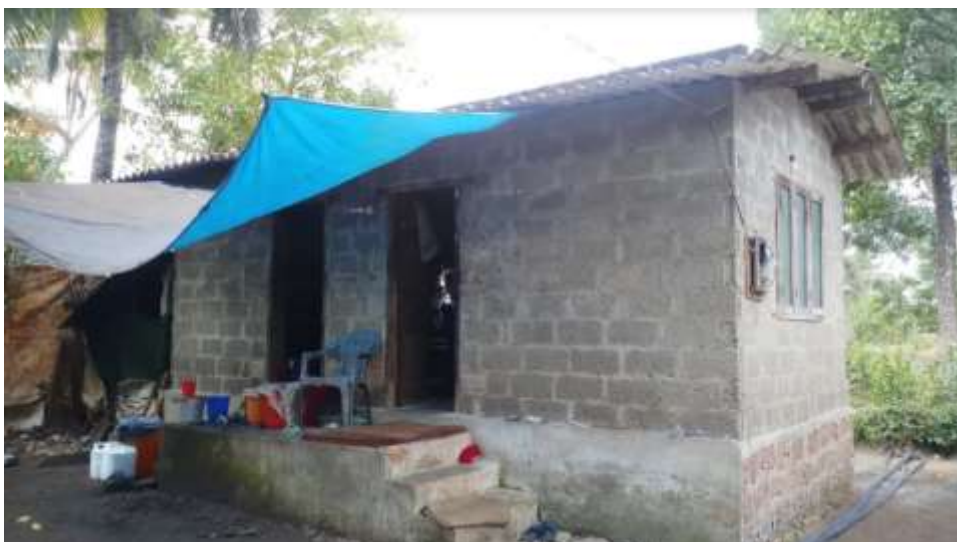
Figure 47: Small House Size in Kainakary (2 rooms) with attached temporary outdoor shed for storage of animals. 2019

Note: While the houses in both villages (Nedumudi average house size = 68.47 sqm (737 sqft); Kainakary average house size = 57.88 sqm (632 sqft)), the average house size is skewed because of sample selection, there are few households with very constrained spaces (between 12sqm to 14 sqm). These houses were mostly occupied by elderly tribal occupants. According to Census of India, the average house size in India is 494 sq ft / 103 sq ft per person in rural areas. Accordingly, both Nedumudi and Kainakary are above average in India.

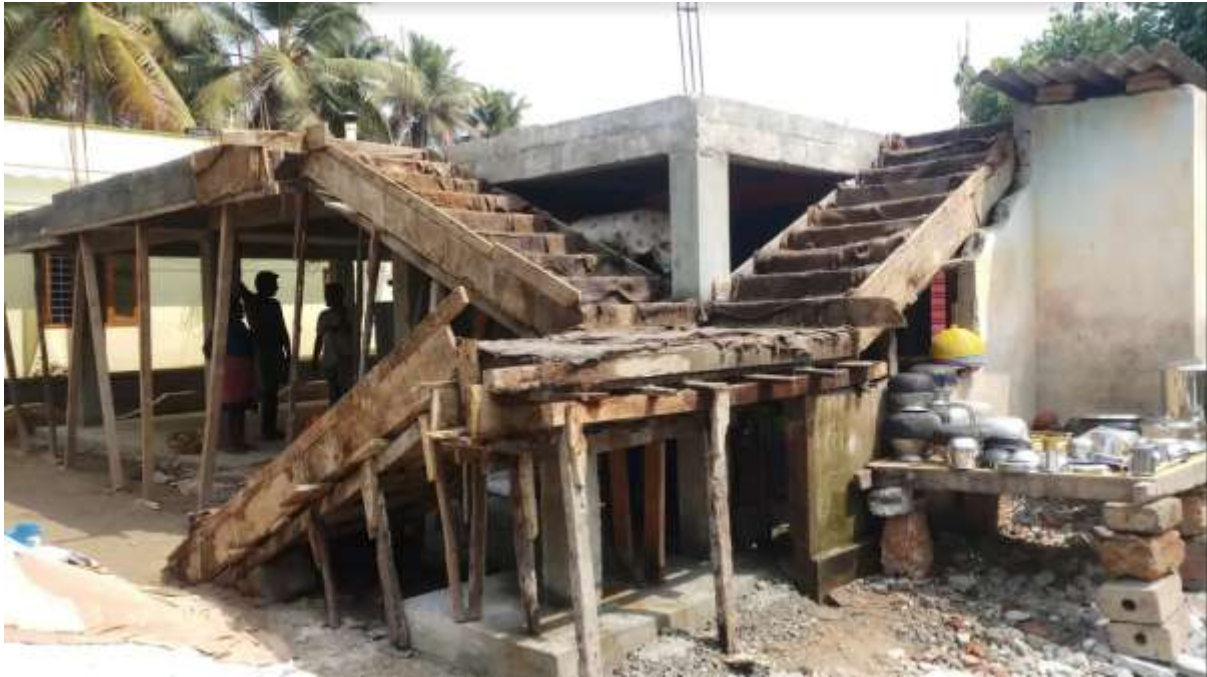
Figure 51: Under construction Frame structure on Stilts in Kainakary, 2019

It should be noted however, that almost all buildings surveyed in the area were single storeyed structures, thus cheaper for load-bearing constructions. However, nature of “foundation” due to the bearing capacity of the Kuttanad soil led to new developments in construction. This has been detailed in section below.

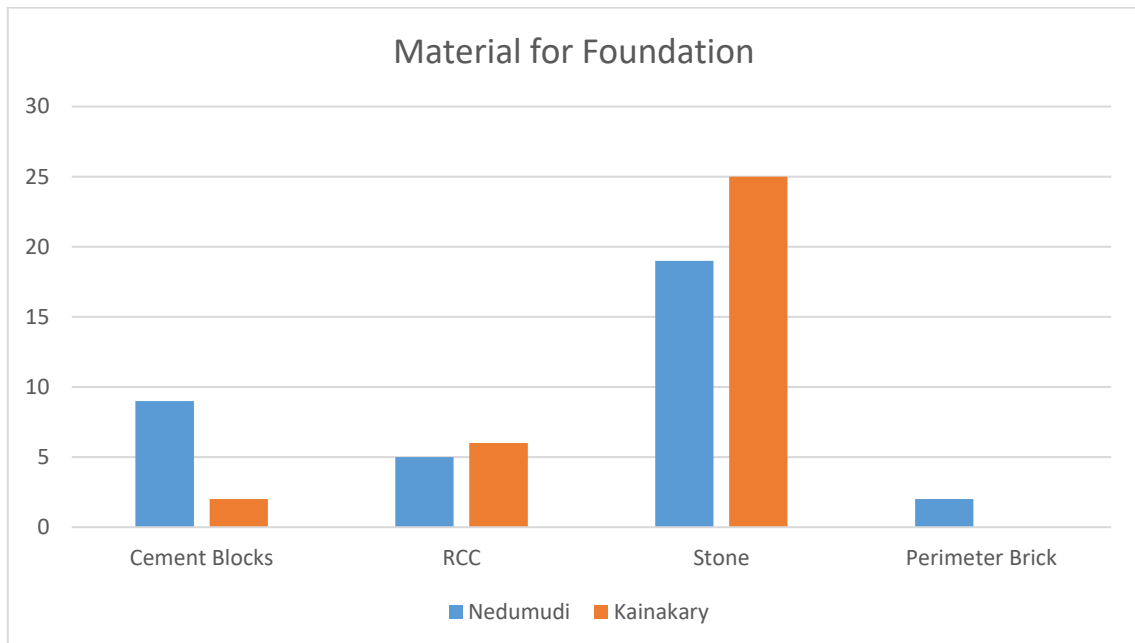
Figure 57: Materials used for Foundation. Survey 2019

Foundations: Primarily foundations are made with salvaged laterite stones

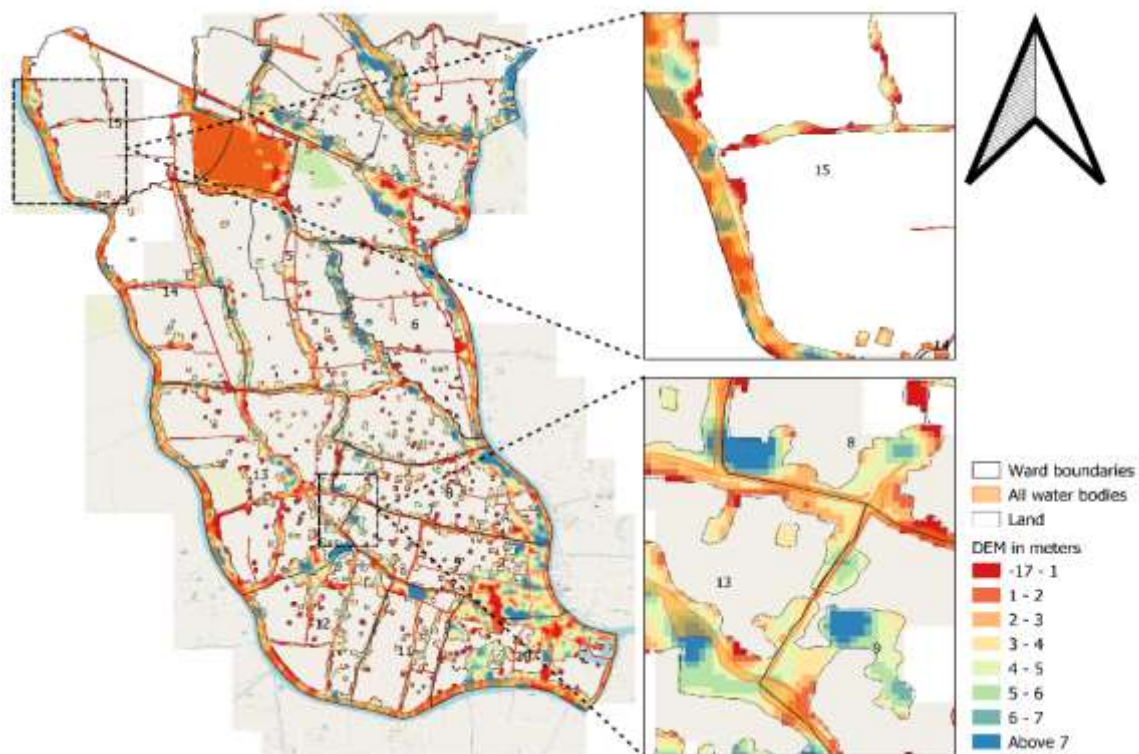
Fig 17: Heat map produced based on topography

with the maximum flood-affected houses, the attribute values of the vector were colour coded from red to blue.

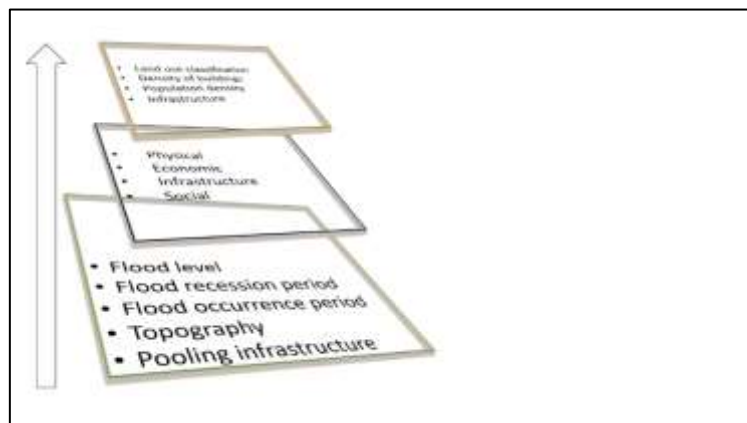
Figure 27: compounding effect of Hazard, Vulnerability and Exposure

By aggregating these variables as permutations and combinations, a clear picture of the compounding vulnerabilities in the regions can be observed (Fig.26) & (Fig.27). The field study attempted to collect these variables individually and the patterns of compounding vulnerabilities.

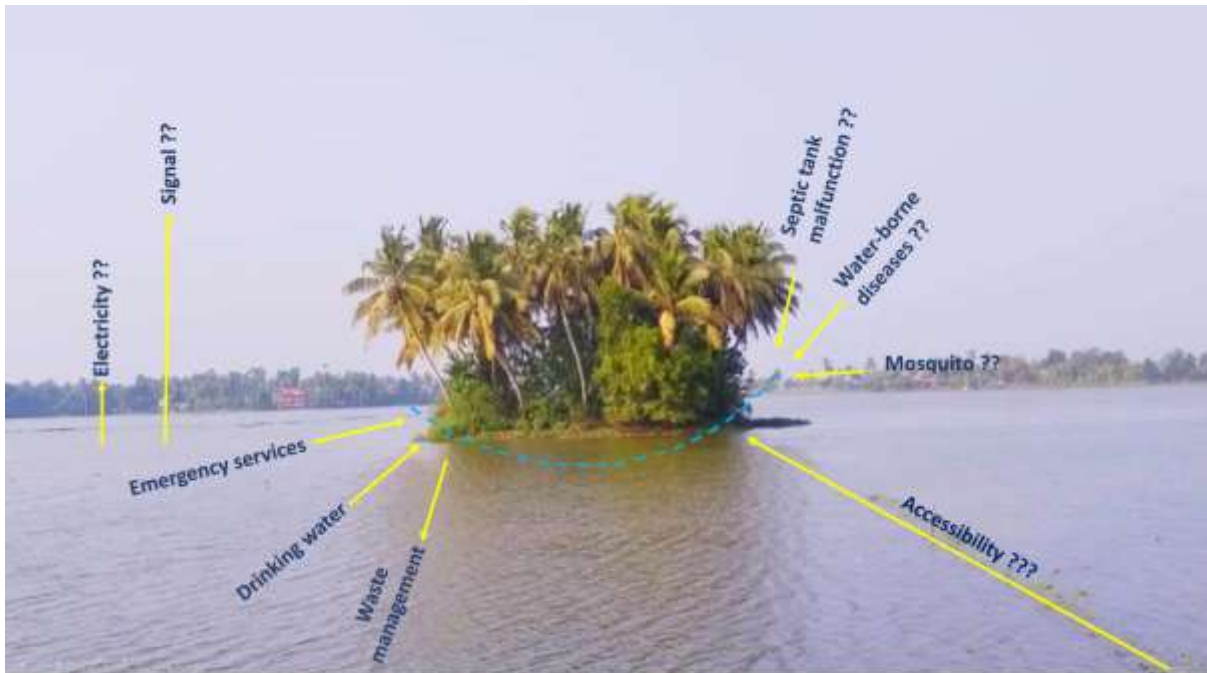
Figure 32: Isolated house in a paddy field, the questions are marked

These are the houses that are located within the islands (*Thuruth*) in the paddy field. These islands have less than 3 houses and are characterized by a lack of vehicular access. The access to the island was through a narrow path (*Varamb*) through the paddy field. During rainy seasons or bund breach events, the paddy fields tend to get flooded at the very first and therefore these houses get isolated if they do not have a boat facility.
